O-Train Confederation Line 1 Update

Transit Commission
October 20, 2021

September 19 Derailment

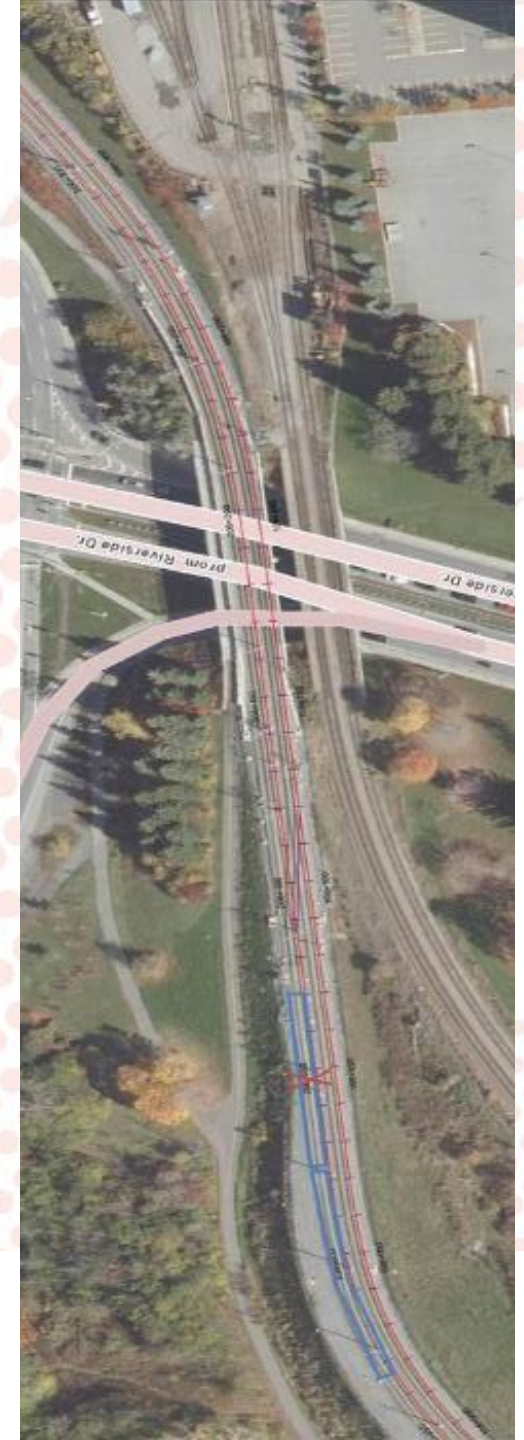
- At approximately 12:15 p.m., a westbound train came to a stop due to a derailed bogie (*2 axles, 4 wheels*) between Tremblay and Hurdman stations.
- All stakeholders were engaged immediately: RTM, Chief Safety Officer, RMCO, TSB and Transport Canada.
- At approximately 12:45 p.m., Line 1 service was suspended and all trains were stopped at the nearest stations.
- At approximately 1:00 p.m., customers on board the derailed train were provided assistance to exit the vehicle.
- Full R1 bus replacement service was implemented end-to-end from the time of the incident to present.

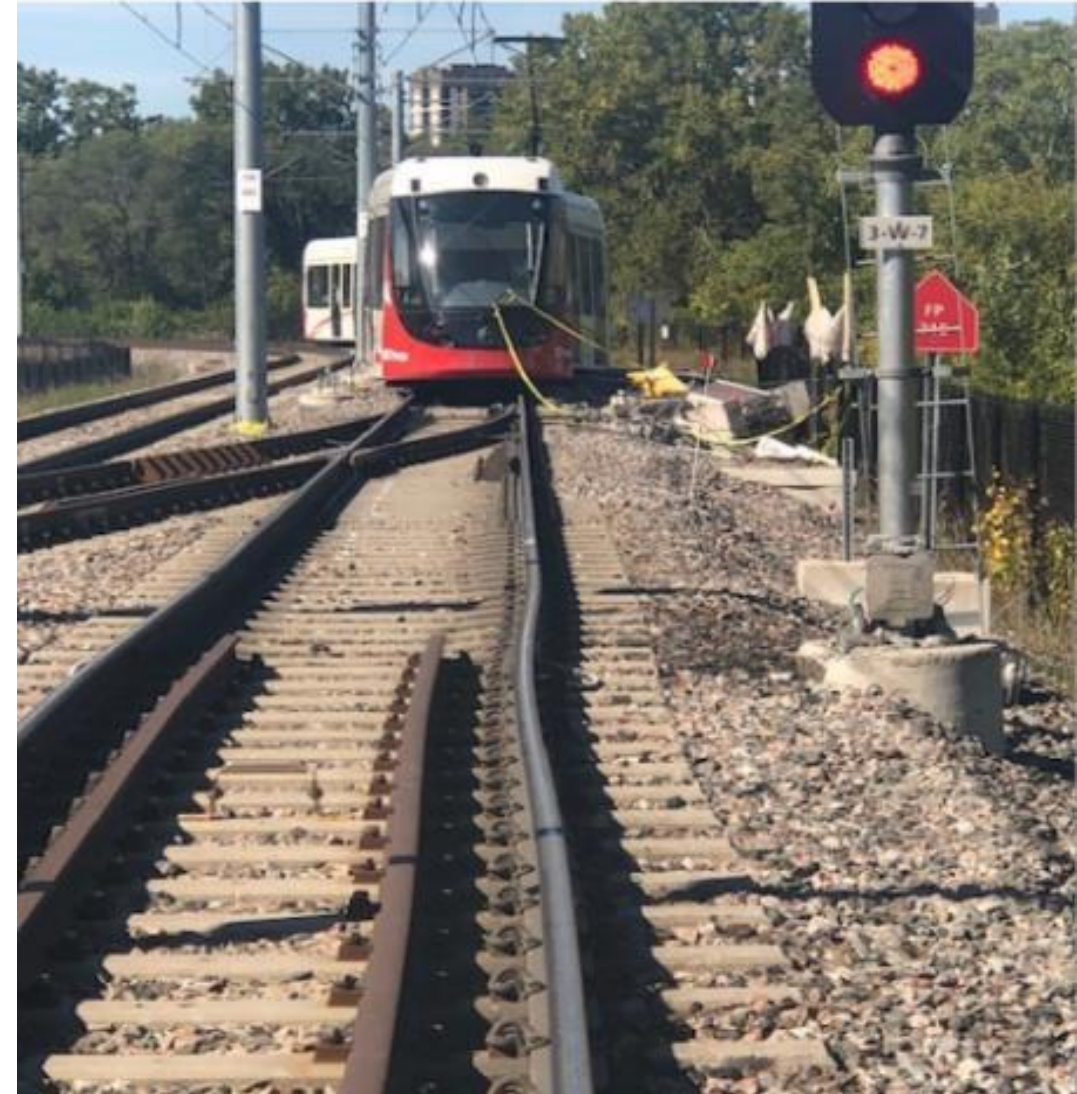
- Each non-impacted train was inspected by a technician prior to being returned to the Maintenance and Storage Facility (MSF).
- Vehicles were driven back at a reduced speed with technicians on board.
- As part of TSB's review of the incident, the City was informed that the affected and any related materials on the guideway were to stay in position, until further notice.
- On September 21, TSB cleared the site, and as a result, the train could be returned to Belfast Yard and infrastructure repair work could start.

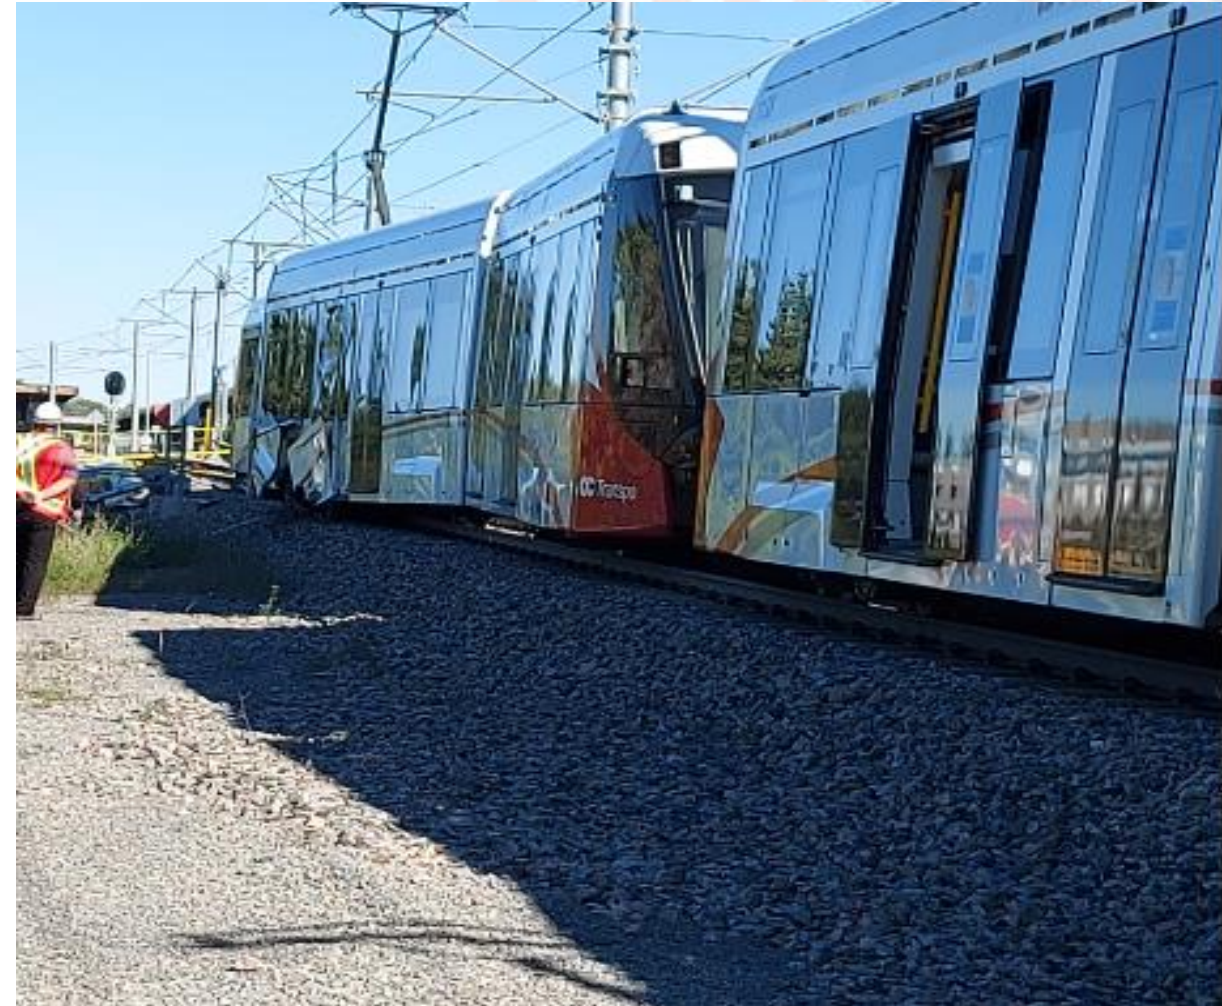
- The train was re-railed and inspected by Alstom technicians prior to being moved at a slow speed under its own power back to Belfast Yard for further analysis and investigation.
- The vehicle was returned to Belfast Yard on September 22.
- Staff walked alongside the train to ensure that the movement was done safely and without any additional damage to the train, tracks and rail infrastructure.

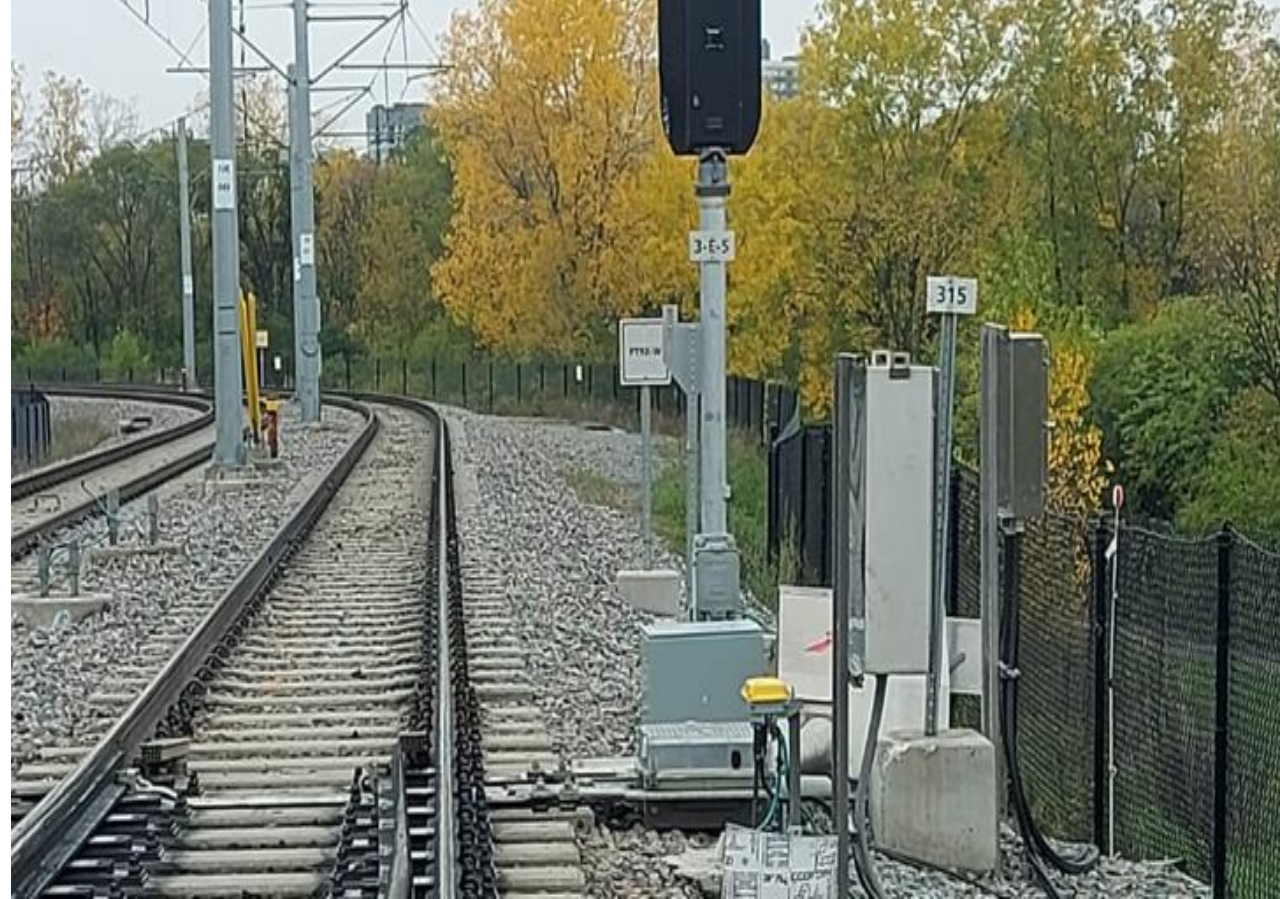
- Prior to the train arriving at Tremblay Station, a gearbox located on the outside of the body started to drop.
- As the gearbox began to drop, it started making intermittent contact with the railroad ties, leaving marks in advance of Tremblay Station.
- The wheels on one of the motor bogies were in a derailed state when the train left Tremblay Station.

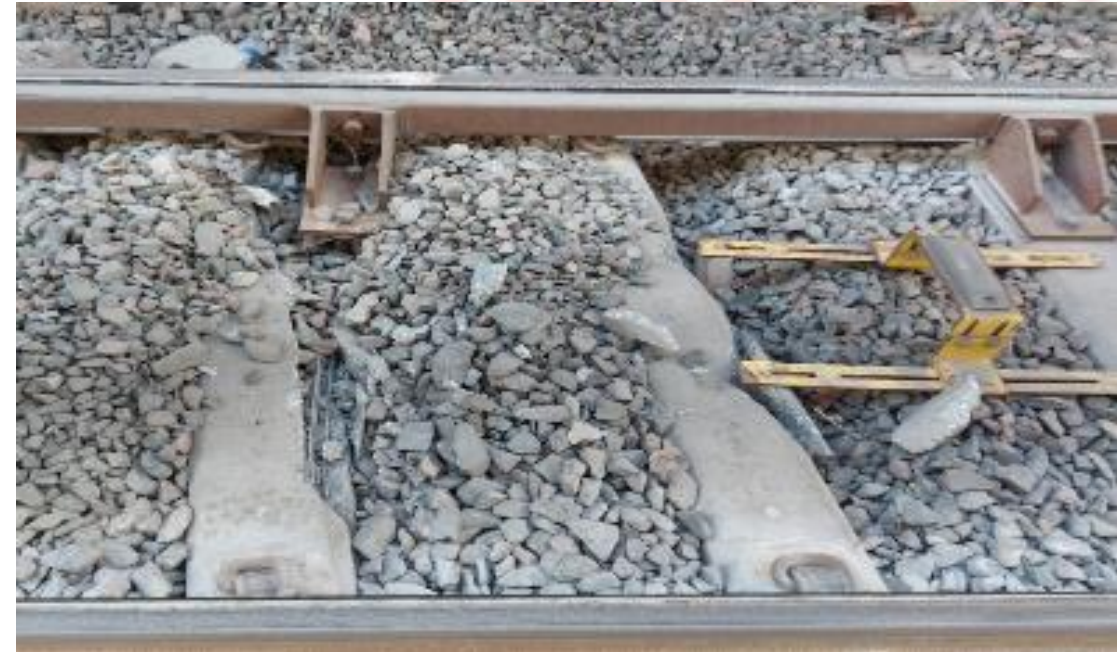
- No abnormalities were noted by the Operator when the train departed the station.
- The train travelled from Tremblay Station to just west of Riverside Drive when the gearbox made contact with a signal mast and a switch heater.
- Communications-based train control (CBTC) system brought the train to a stop.
- There was significant damage to the train and rail infrastructure.
- The LRV passenger door above the affected bogie was damaged.

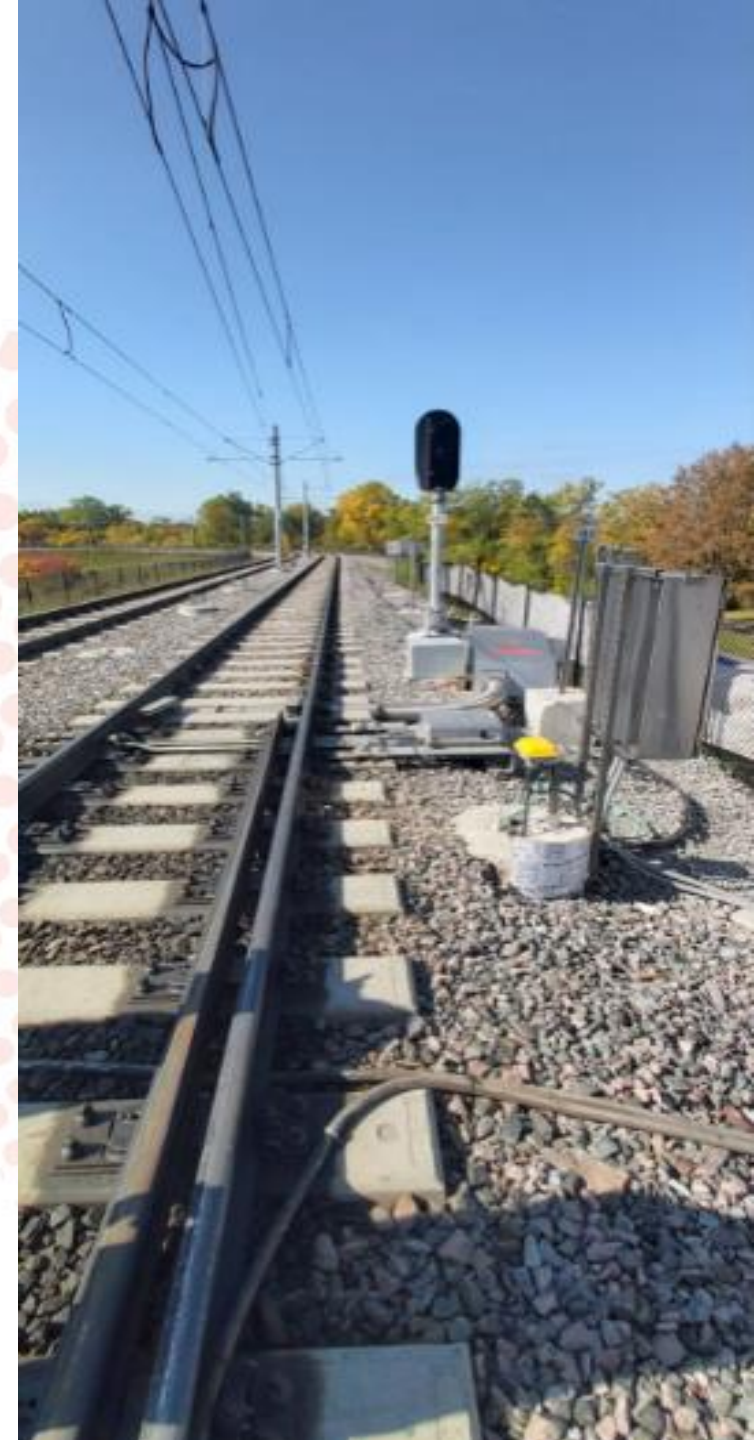
- Switch machine and switch heater damaged.
- Signal post and concrete pad damaged.
- Broken and chipped concrete ties, rails clips and clamps, track bolts and ballast were damaged and required replacement.

- Gearbox and related components:
- Traction motor and components.
- Wheels, train door, side body and glass panels.
- Maintenance, corrective repairs and fleet checks continue on all LRVs.

- All track and infrastructure repairs were effectively completed by October 18. All systems will undergo verification testing prior to confirming their release for service.
- Test trains will be required for additional measurements and validation of the infrastructure.
- An intensive fleetwide inspection is required to assess and validate the integrity of all the trains.

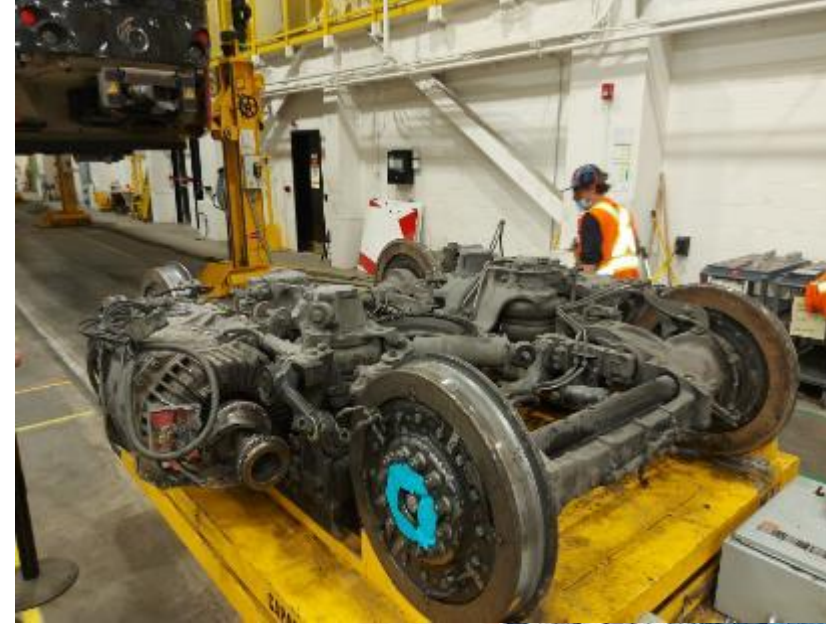
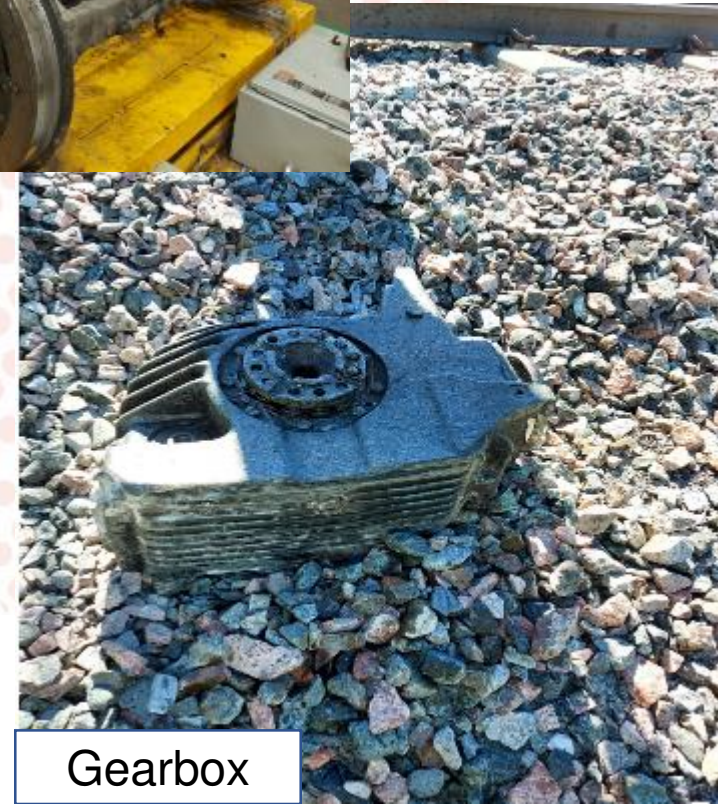
- The root cause investigation into the September 19 derailment continues.
- The derailed LRV had recently undergone axle repairs to replace the axle bearing assembly from the August 8 derailment.
- Initially believed to be an issue with the sanding bracket, subject to the ongoing investigation, RTG and Alstom have confirmed that the improperly torqued bolts on the gearbox is the primary cause of the derailment.
- The gearbox appears to have dropped down and impacted the rail and track infrastructure.

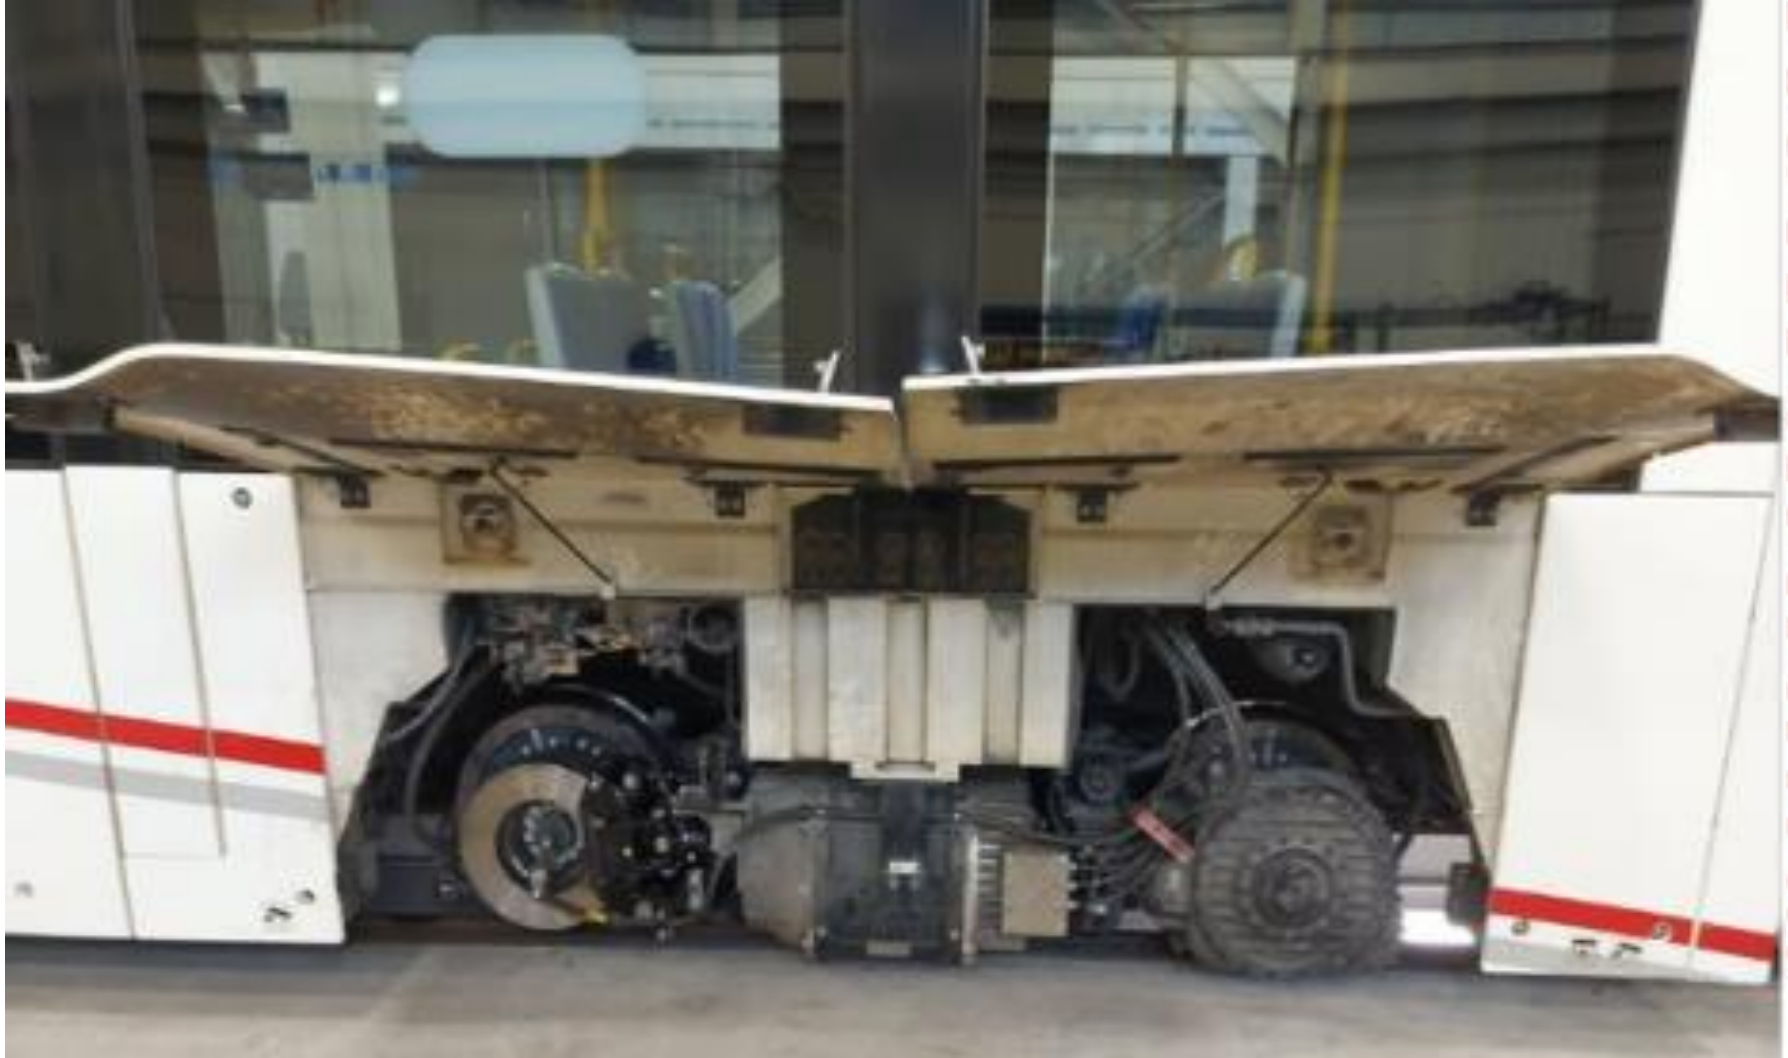
Bogie installed on a LRV

- LRVs have five bogies per car (3 motor bogies + 2 trailer bogies).
- Motor bogies are comprised of many components including axles, wheels, bearings, frames, brakes, motors and gearboxes.
- The gearbox is the mechanism that couples the motor to the axles.
- The gearbox facilitates the energy transfer from the motor to the wheels, which is required to propel them forward.

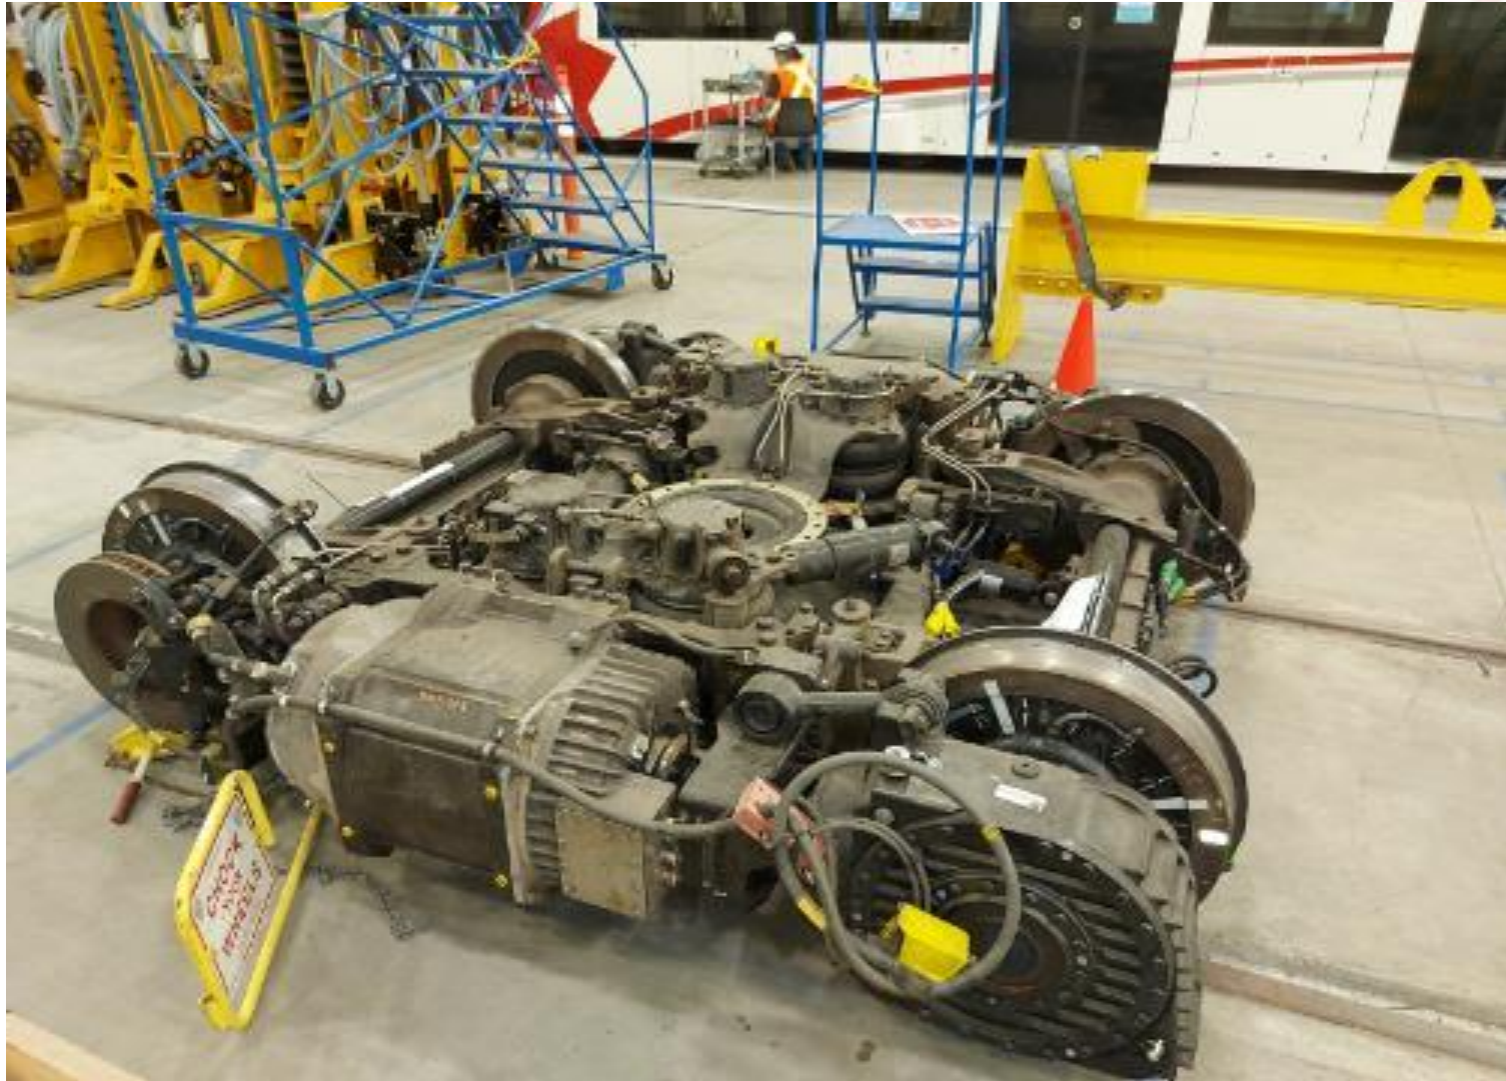
Bogies at Belfast Yard

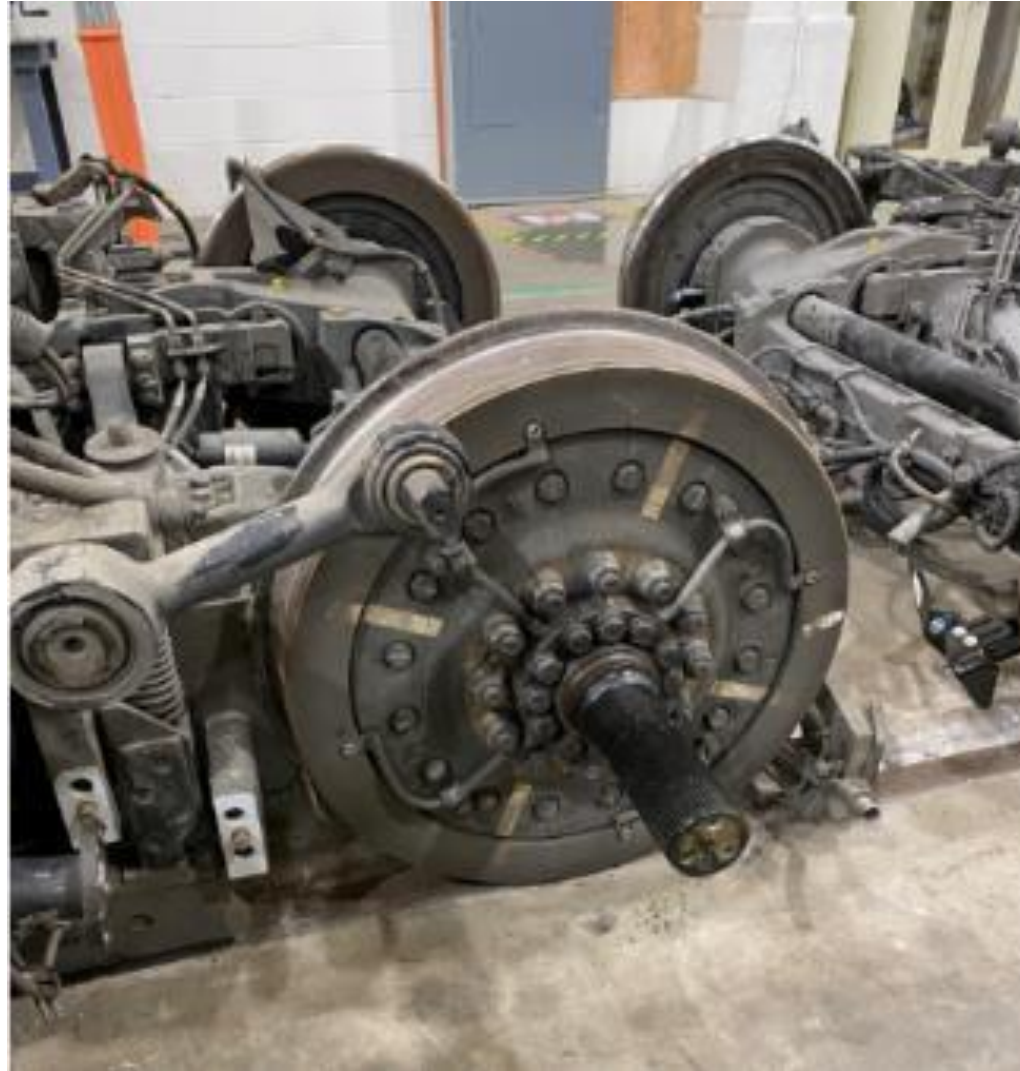
Bogie with gearbox removed (undamaged)
